Comprehensive Environmental Inc.

Study of Urban Non-Point Source Pollution Boire Field Brook Subwatershed

PENNICHUCK WATER WORKS SPRING 2000

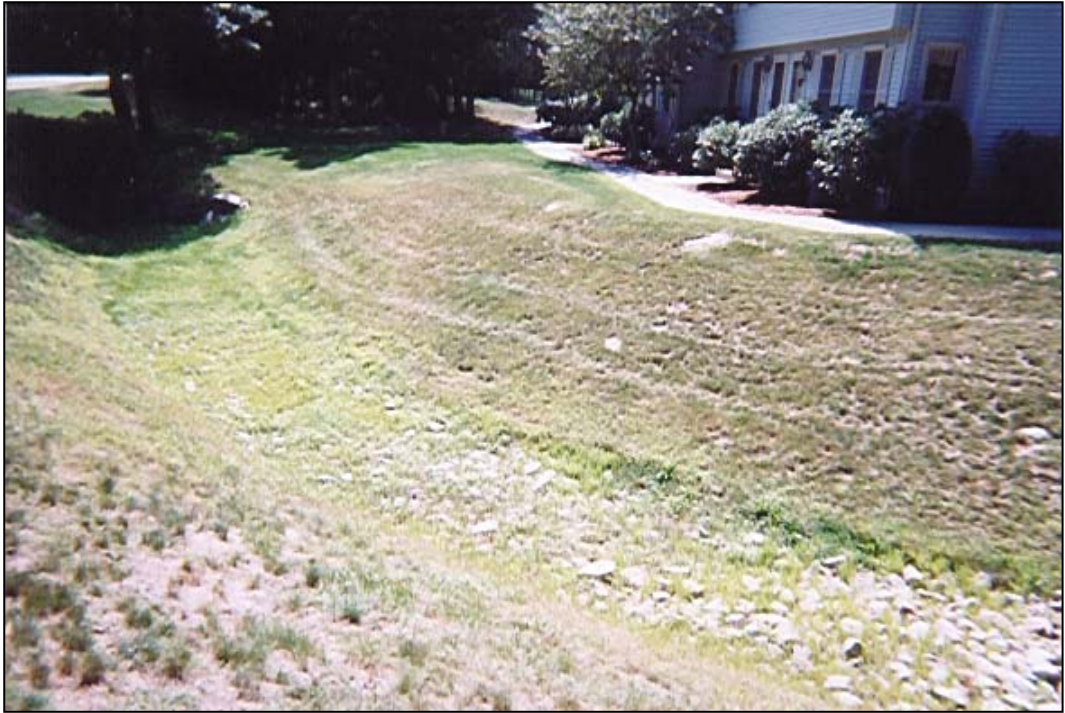
Figure 2-2. Kessler Farm Swale

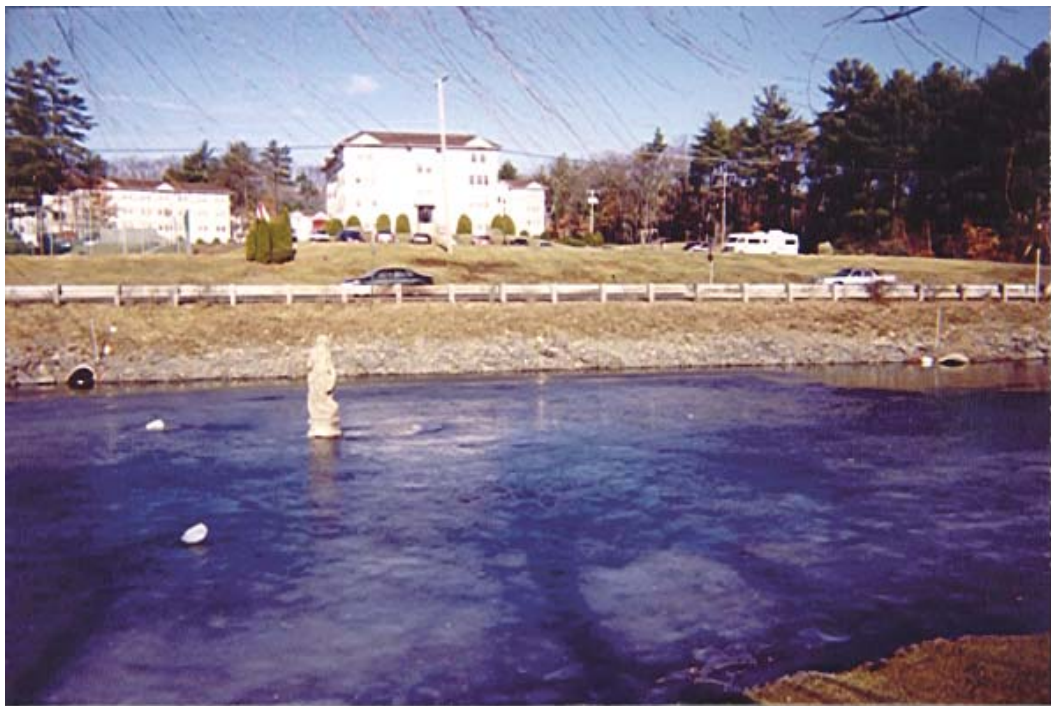
Stormwater from the southern aspect of the Kessler Farm development and access drive does not benefit from as long a detention time as it short circuits the flow path seen in green on Figure 2-1 and instead discharges directly into the last detention pond (Figure 2-5) before crossing under Somerset Parkway.

Figure 2-5. Stormwater Discharges to Crowne Plaza Detention Pond

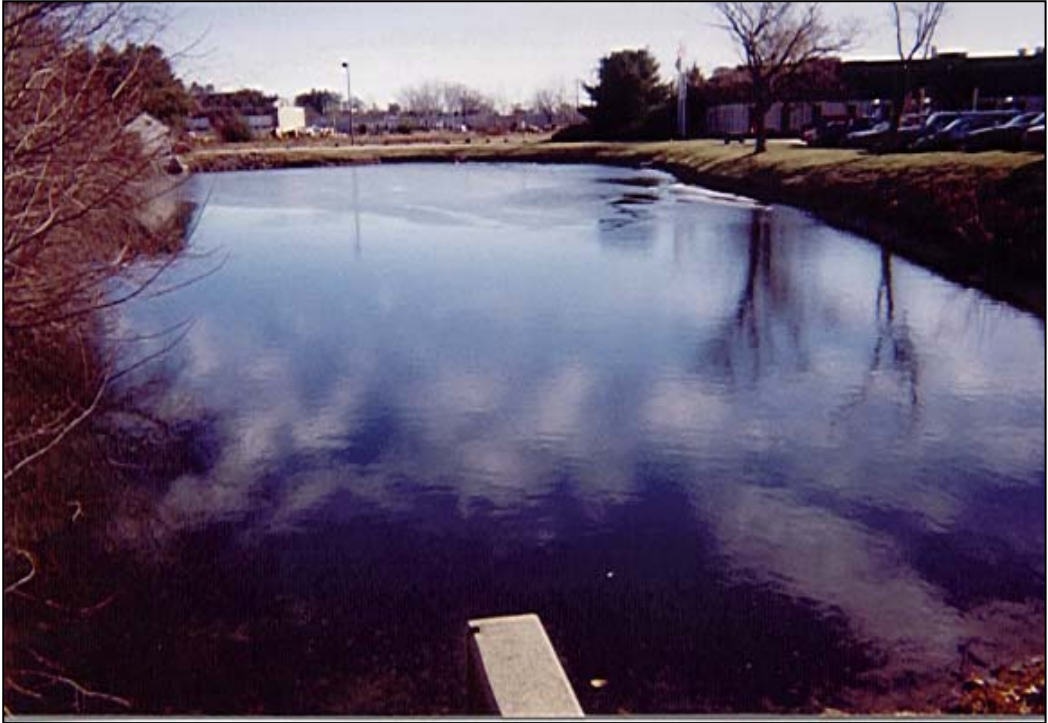
Most runoff generated south of Amherst Street in the vicinity of the Compaq computer facility flows to a detention pond (Figure 2-6.) and then northerly towards Somerset Plaza into the same swale (Figure 2-7)

Figure 2-6. Compaq Detention Pond

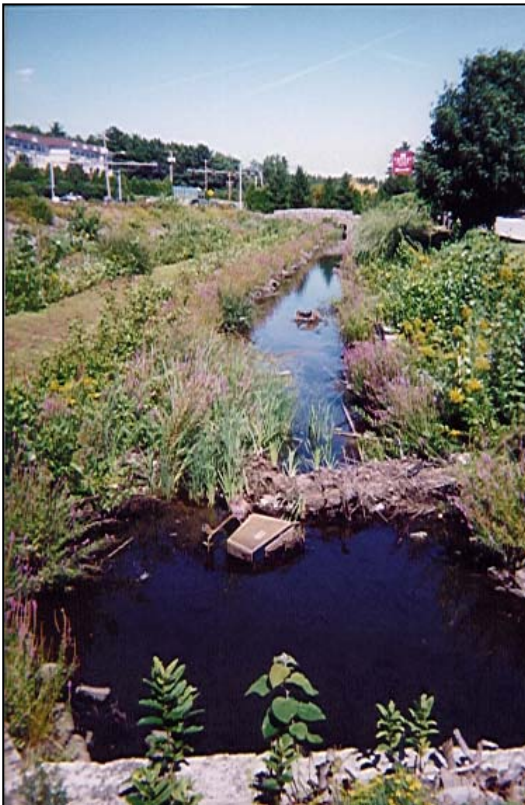
**Figure 2-7.
Somerset Plaza
Wet Swale**

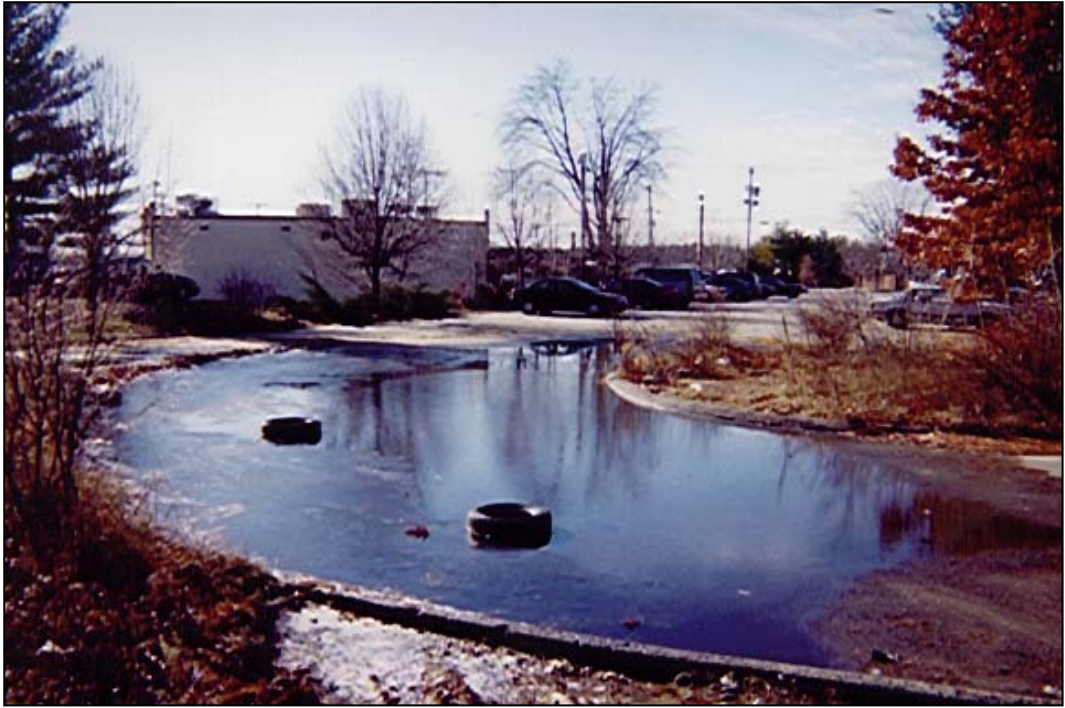
Stormwater generated north of Amherst Street, and inclusive and west of Sullivan Tire (Figure 2-8) flow westerly in one of two swales that surround and pick up flows from Somerset Plaza.

Figure 2-8. Sullivan Tire Runoff

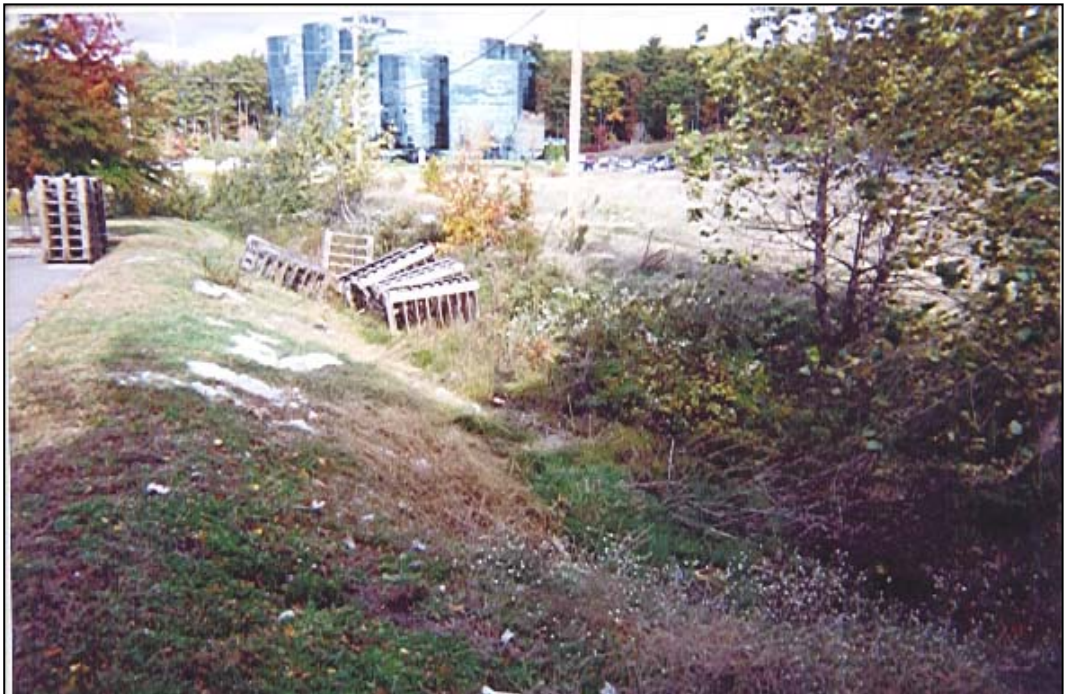
A portion of Trafalgar Square Road and a portion of the parking lot drainage north of Pfeiffer Vacuum flows to the swale on the northern perimeter of Somerset Plaza (Figure 2-9). The water in these perimeter swales flows to the detention ponds fronting on and eventually crossing underneath Somerset Parkway with discharge into Pennichuck Brook.

Figure 2-9. Northern Perimeter Swale

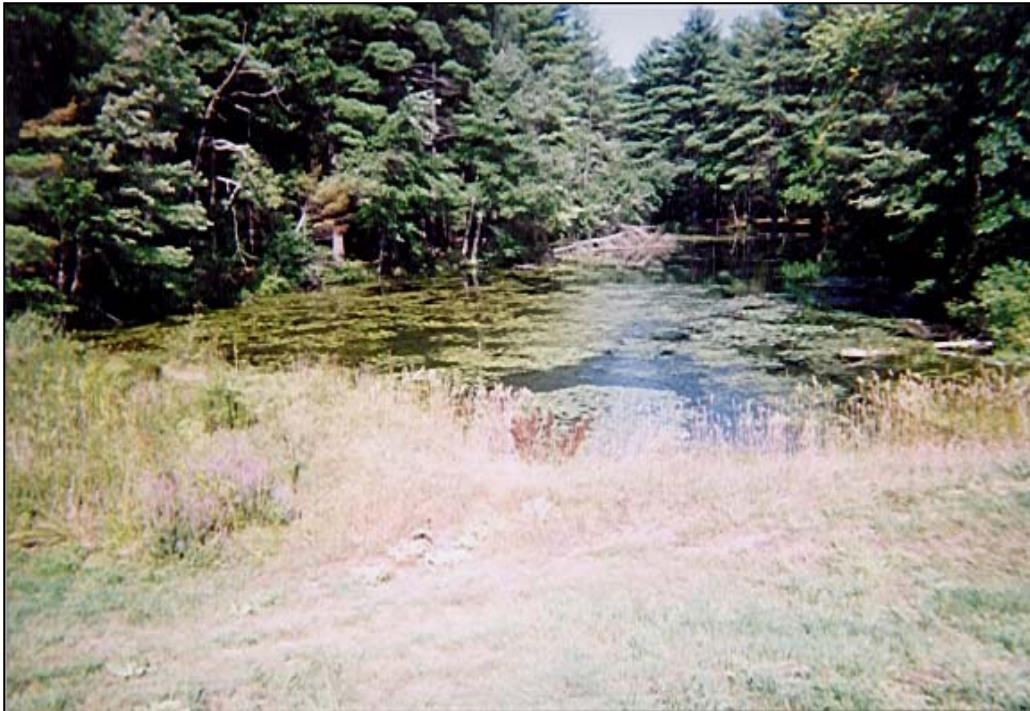
Water from these and other adjacent areas discharges to Pennichuck Brook, which flows under Tinker Road, through a controlled outlet, under the Everett Turnpike to another controlled outlet (Figure 2-14) that discharges to Harris Pond.

Figure 2-14. Controlled Outlet to Harris Pond

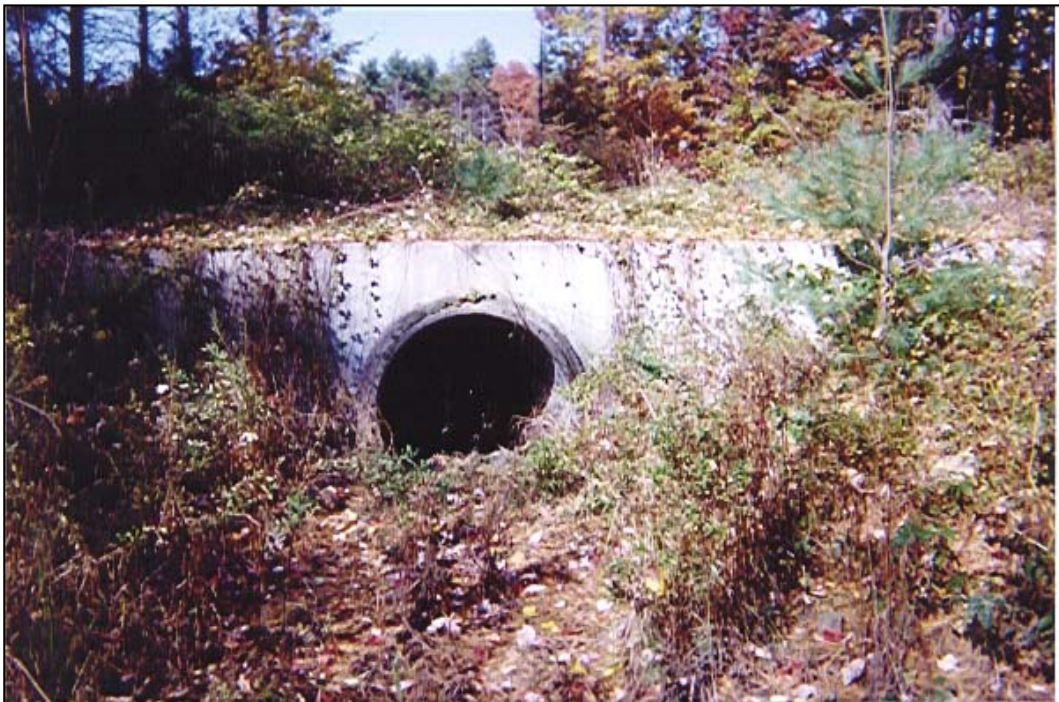
Some of the stormwater in this area flows through grass treatment swales before it enters the main stem of the Pennichuck Brook. The discharge pipes in this area are quite large (Figure 2-15), presumably to handle the stormwater from development of the presently vacant lands. Although two of the grass swales appear to be intact and functioning properly, there was little evidence to suggest that either had experienced high flows.

Figure 2-15. Large Discharge From North Southwood Drive

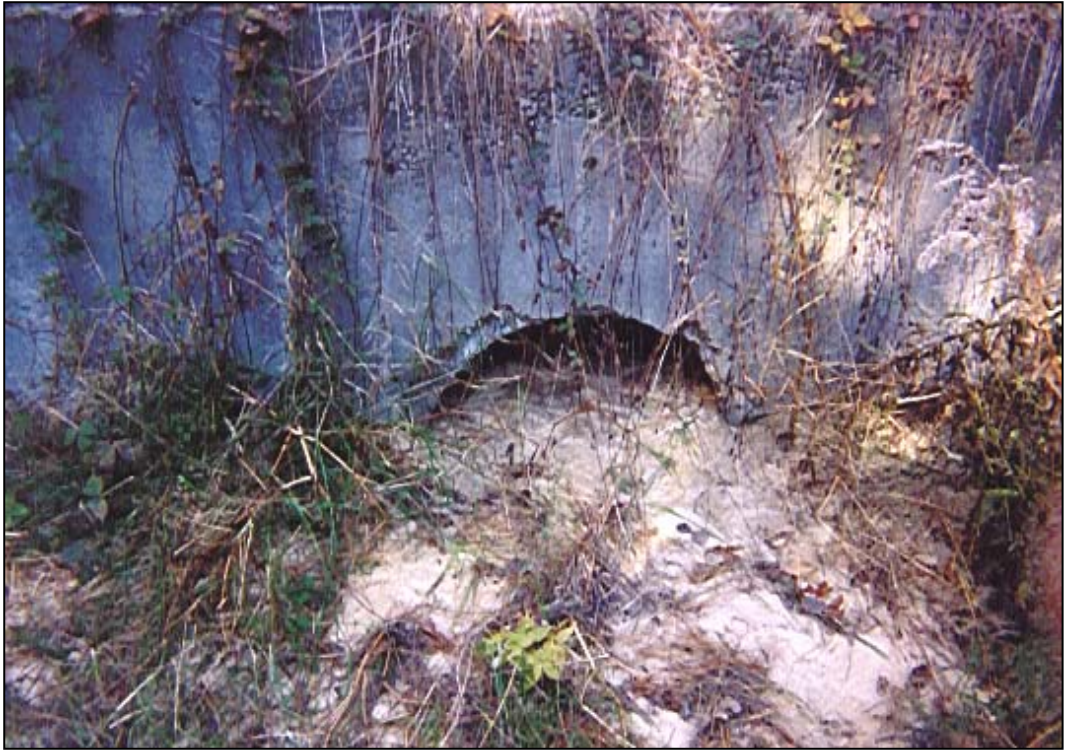
Another treatment swale located downstream, however, showed signs of extreme sedimentation (Figure 2-16) to the point of almost complete blockage. This swale handles stormwater from the Cornerstone Computer site located on north Southwood Drive. Much of the beneficial vegetation in this grass treatment swale has been choked by sand. The remaining vegetation consisted of small woody plants typical of disturbed soils. These plants offer little treatment of stormwater beyond their minor energy dissipating qualities.

Figure 2-16. Cornerstone Discharge Blockage

Because of the large volume of sand and sediment contained in the stormwater, the pipe's discharge has become clogged. The source of sand and sediment found in the existing grass swale was traced to a developed site that discharges rooftop and parking lot runoff onto a steep slope before entering the conveyance system. Stone has been placed on top of fabric on the receiving slope of this upstream site in an attempt to protect the slope from erosion (unfortunately the stone that has been used is relatively flat and does not have the many faceted, angular structure required to function as riprap). The stone has slid down the fabric and the unprotected lateral walls have slumped and eroded (as seen in Figure 2-19). Much of this eroded material has been carried through the storm pipe and discharged onto the existing grass swale.

The swale is in need of some minor regrading to re-establish its original design slope (See figure 3-4). Cleaning accumulated sediments from the pipes discharge (as shown in Figure 2-16) should be done at this time.

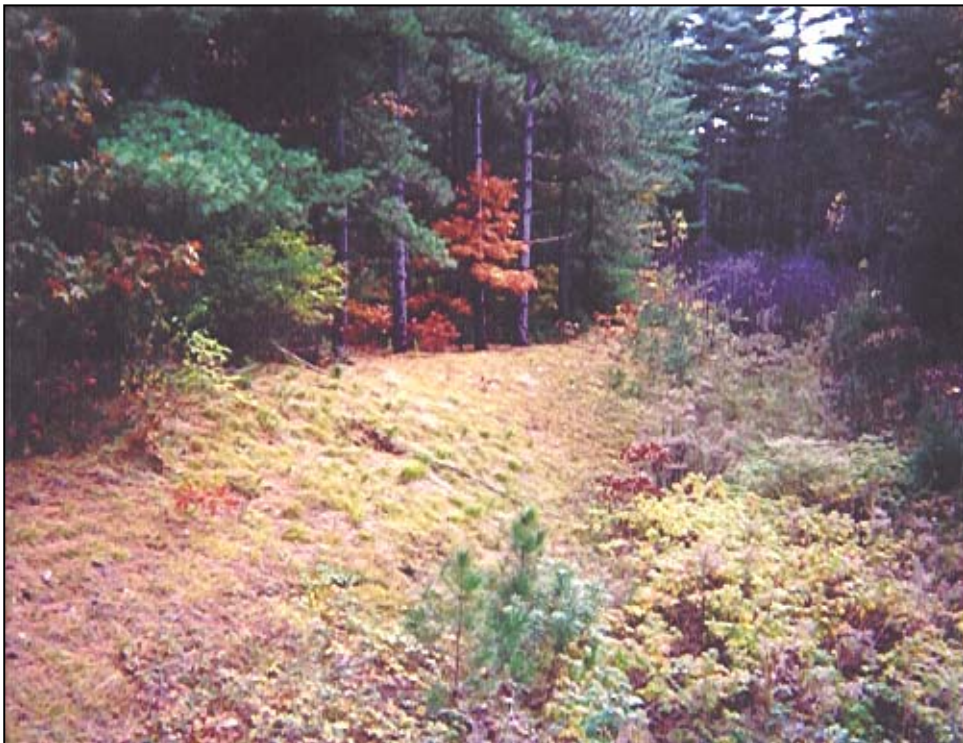
This discharge site (Figure 2-17) and an upstream collection junction (Figure 2-18) were picked for installation of BMPs and are described in greater detail in section 3.1.

Figure 2-17. Existing Grass Swale

Stormwater generated on the impervious surfaces at the Cornerstone Computer Facility receives some treatment from an existing grass treatment swale before it enters Pennichuck Brook. However, the grass treatment swale has been choked with sand and sediments contained in the stormwater and possibly the side slopes of the swale itself. While some infiltration exists in the sandy soils that underlie the swale, it appears that high velocity stormwater flows down through the swale as noted by the settling (Figure 3-1 located at the end of this section) of large particles quite a distance from the pipe's discharge.

The third BMP component is the reconditioning of the existing grass swale so that it polishes stormwater from the above two components prior to its entrance to Pennichuck Brook. Reconditioning should consist of some minor regrading, re-vegetation and bank stabilization, and the addition of two check dams. These three efforts are described below.

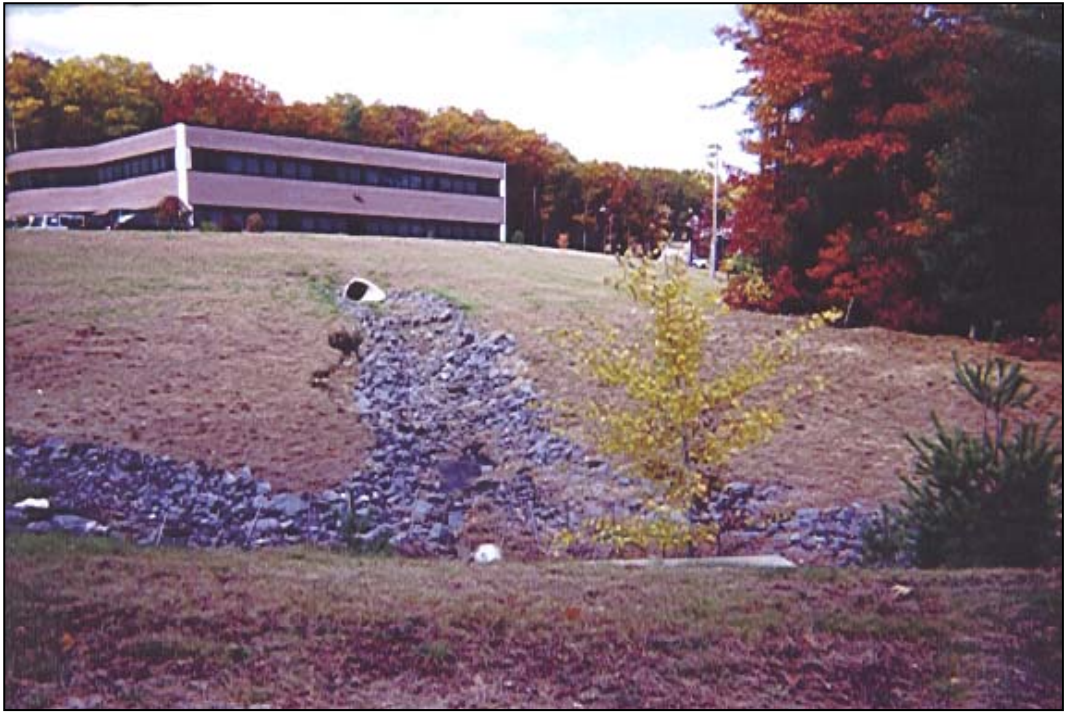
Figure 2-18. Stormwater Collection Junction for the Cornerstone Site

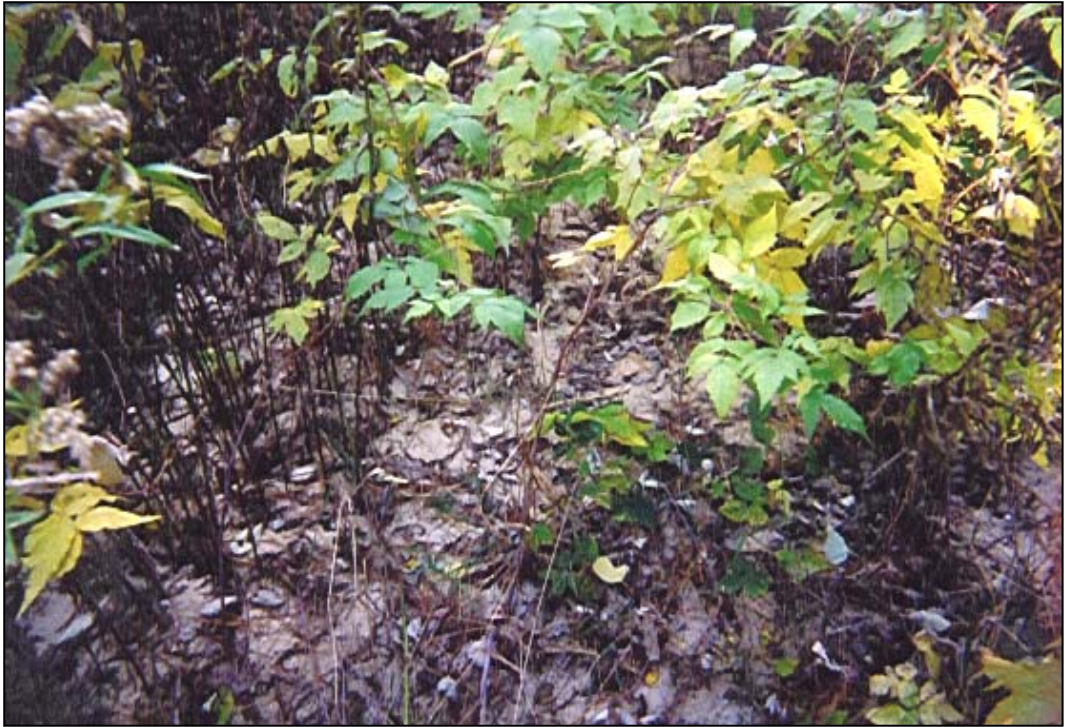
Figure 3-1. Settling of Large Particles

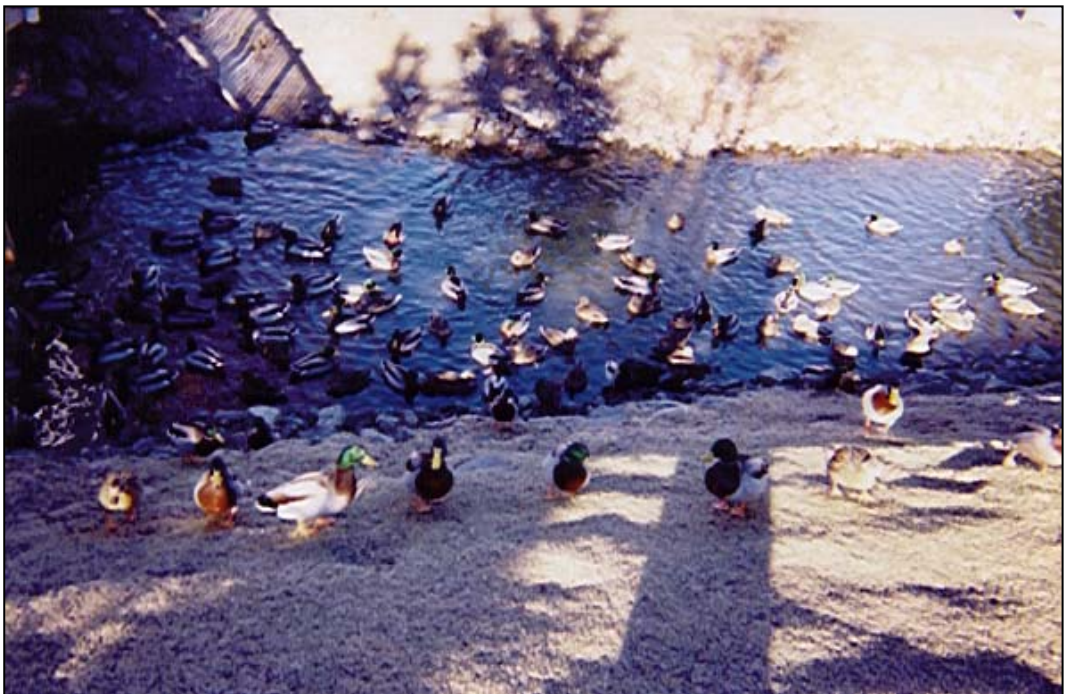
The abundance of waterfowl (see Figure 3-6) that defecate both in and along the banks of the Crowne Plaza detention ponds are a source for both bacteria and phosphorus. Currently, both bacteria and phosphorus pose the most significant threat to Pennichuck's water supply. The reasons for this are twofold.

Figure 3-6. Typical Waterfowl Concentrations in Crowne Plaza Pond

A multifaceted approach is necessary to control waterfowl. Public education in the form of signs around the pond and leaflets in the lobby of the hotel would be useful in explaining to guests the importance of not feeding ducks at this location. Articles in the paper and leaflets in the lobbies of the adjacent businesses will reach locals and employees who might otherwise spend a lunch hour feeding the ducks. If ineffective, an ordinance prohibiting the feeding activity may be needed. Three methods of deterrents and ordinance adoption are explained below.

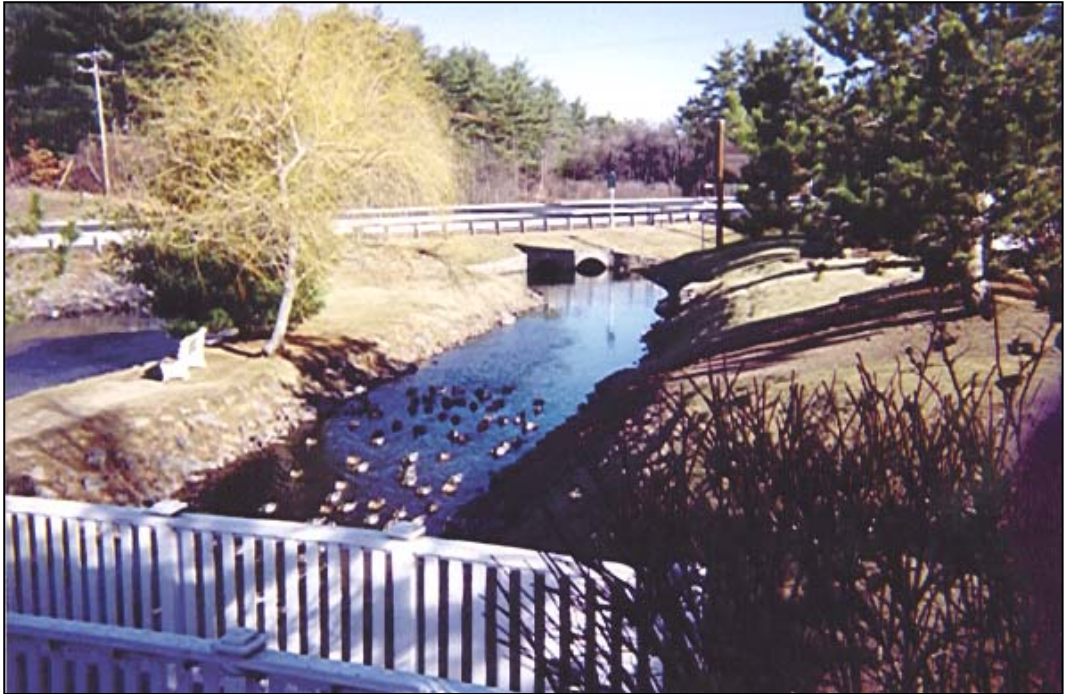
Figure 3-7. In both winter and summer, ducks preferred this narrow pond. Installation of physical deterrents here are less costly.

Structural deterrents are numerous, but many are impractical for this compact urban setting. One method that has been used successfully once the human food source has been eliminated is to make a pond unattractive to ducks by suspending small diameter wire slightly above the water surface in a grid network. Purchase and installation of gridding can be expensive, but many variations of this deterrent idea are possible using cheaper materials or limiting its installation to only those areas preferred by ducks (see Figure 3-7). Grids for ducks should be five feet by five feet and heights may be from two inches to three feet off of the water.

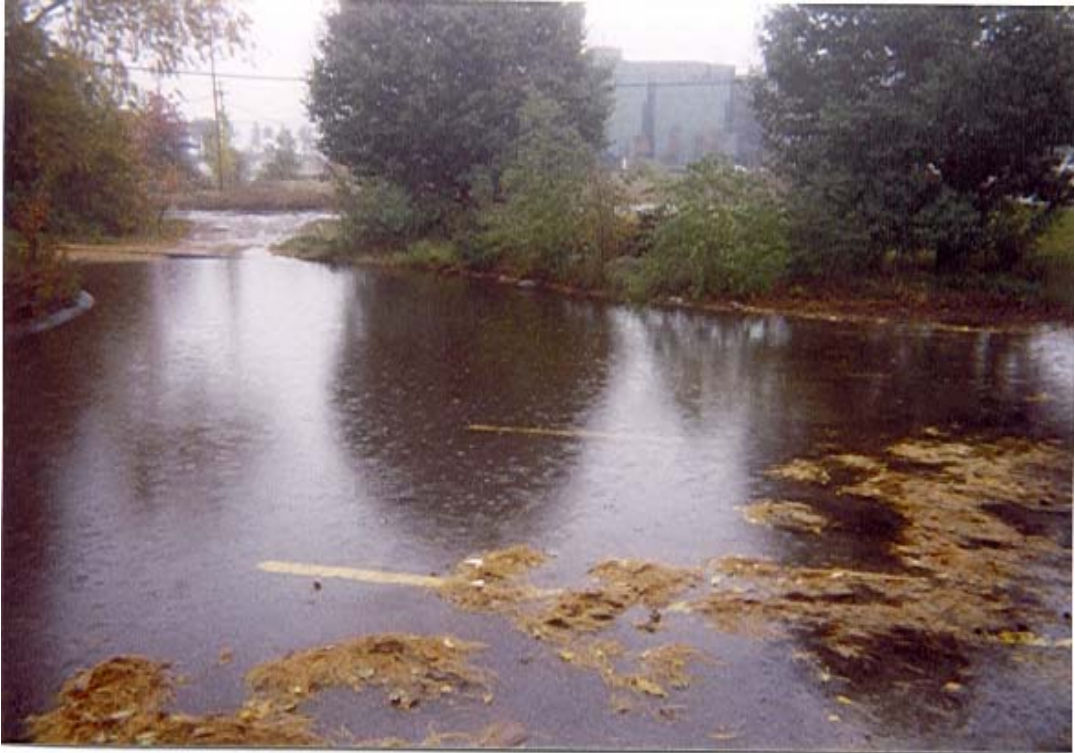
Figure 4-1. Ponding Problem at Sullivan Tire

Simply cleaning out the accumulated sediments would solve the ponding problem, however from a water quality standpoint, the frequent appearance of a petroleum sheen (Figure 4-2.) on the surface of the water indicates that the ponding “problem” may, in the short term, act to help treat the water. The ponding that occurs now detains the water and thus gives the floatable material a chance to degrade.

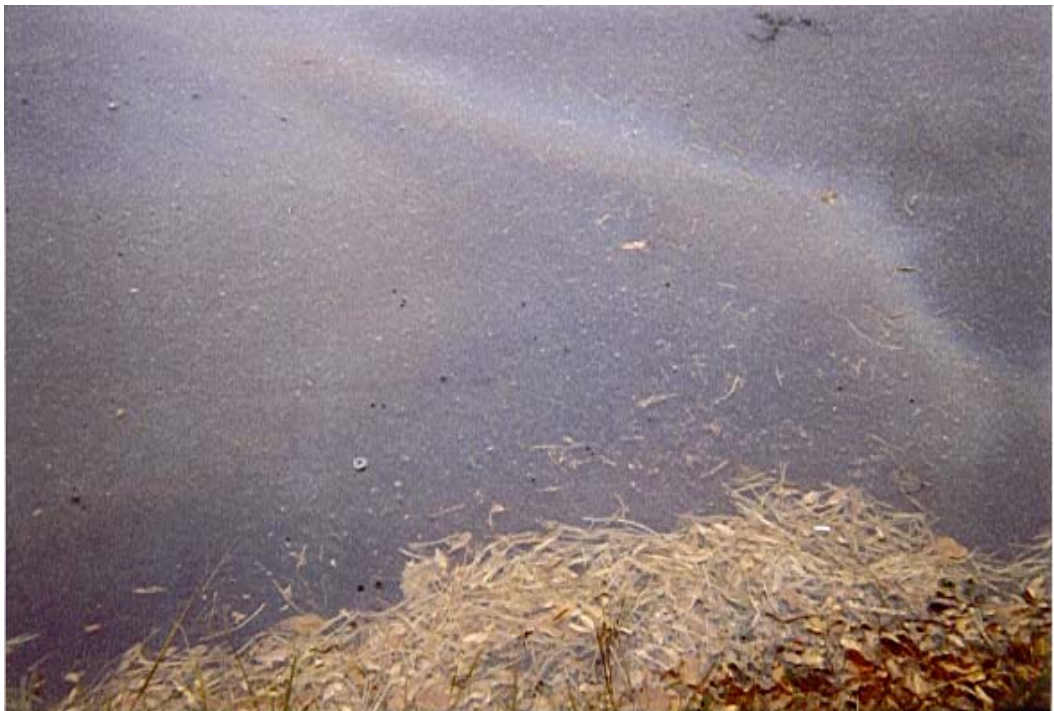
Figure 4-2. Petroleum Sheen at Sullivan Tire

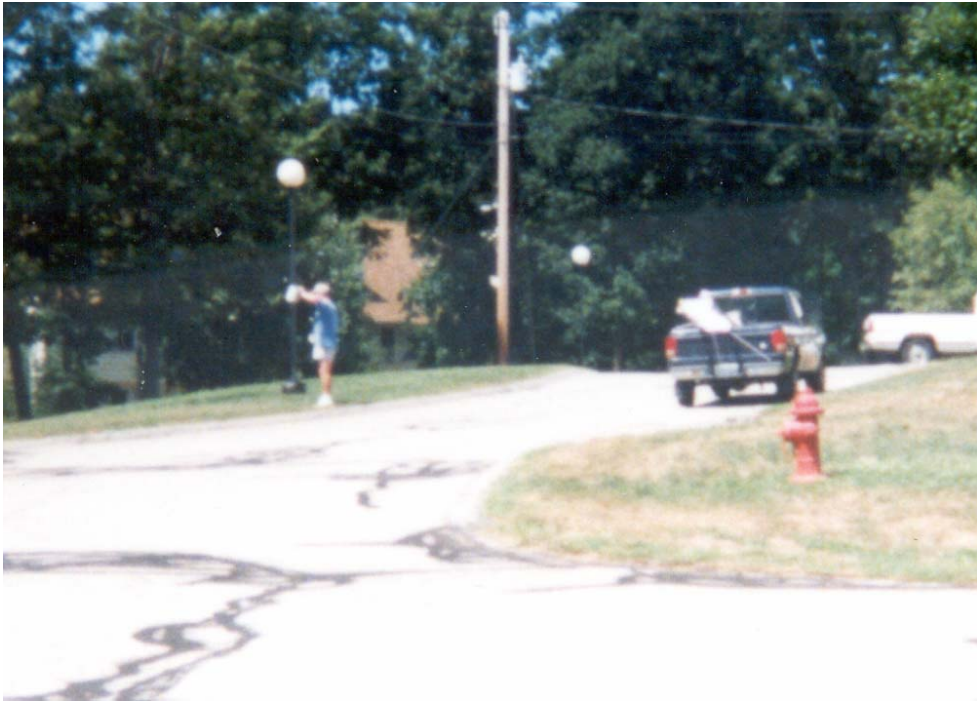
Figure 4-3. Paint Thinner Being Dumped in Catchbasin
