Comprehensive Environmental Inc.

Study of Urban Non-Point Source Pollution Pennichuck Brook to Bowers Pond Subwatershed

PENNICHUCK WATER WORKS MARCH 2001

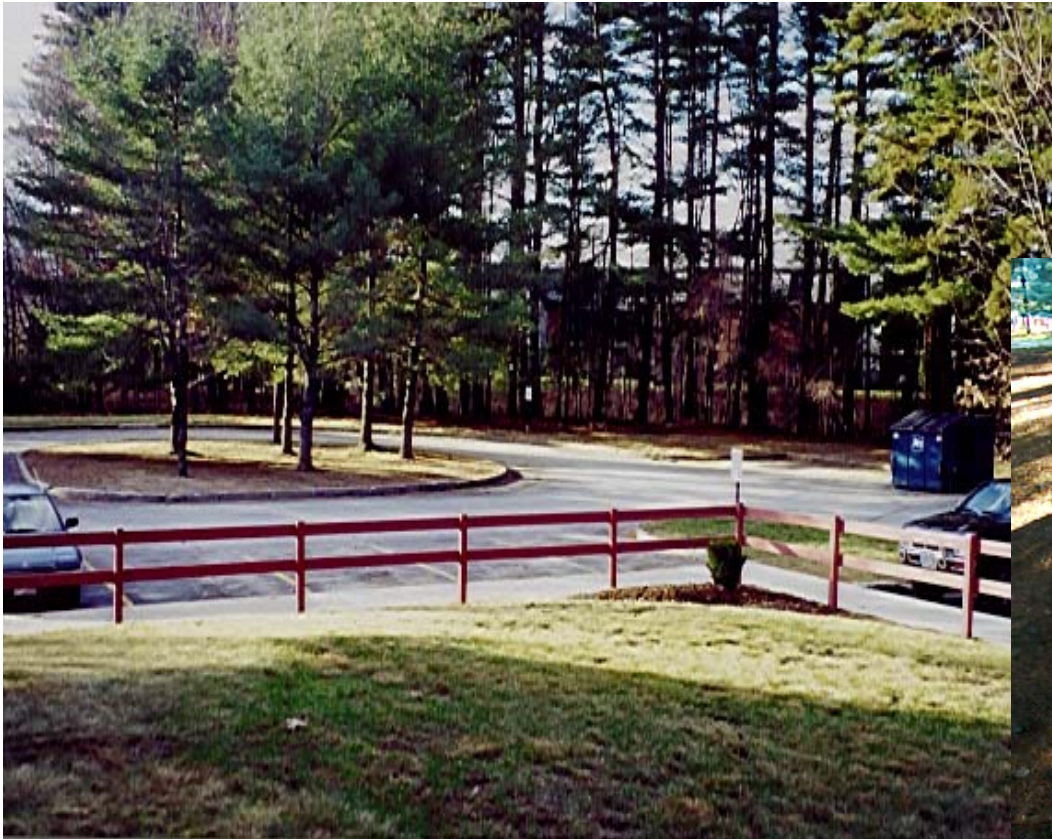
Figure 2-5. View of Contributing Drainage Area to Discharge.

Area A-2 is located in the same development as A-1, but collects a different portion of the drainage (Figure 2-5). It too has a discharge (Figure 2-6) to the Blackstone detention pond outlet stream. Although a smaller volume, the stormwater enters the stream closer to its eventual discharge into Holt Pond.

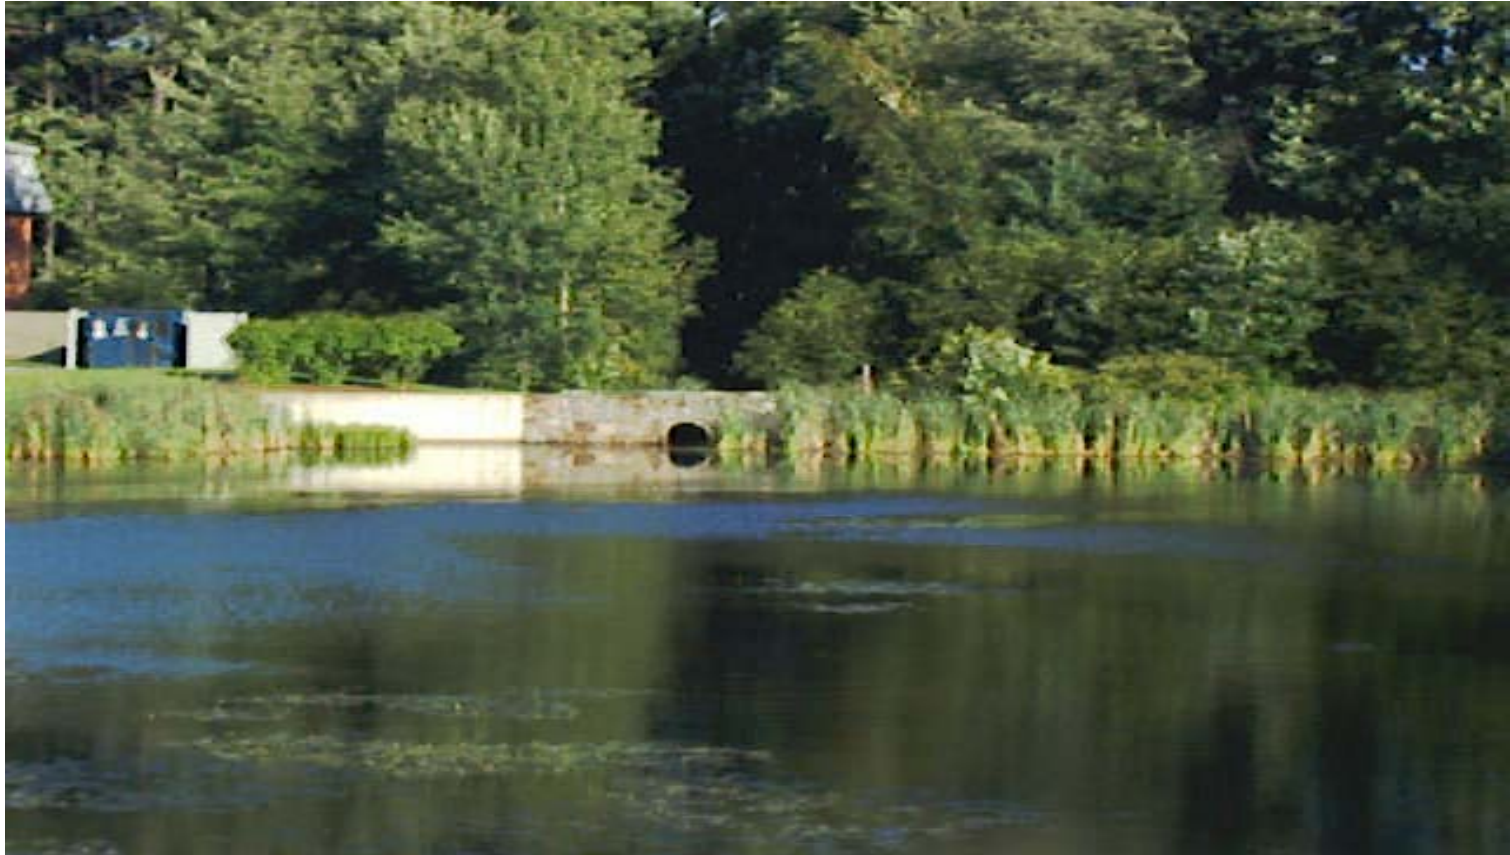
The detention pond (Figure 2-7) located East of Blackstone Drive serves as a point of stormwater collection for surrounding industrial and residential areas. The pond receives limited overland runoff in addition to its two major inlets from Blackstone Drive and Route 101A. The drainage area that contributes to the Blackstone pond (see hatched area on Figure 2-2) consists mainly of impervious surfaces that collect a great deal of sediment and trash. Consistent with previous studies, field staff noted substantial sediment deposits and evidence that the pond infilling may be compromising its ability to treat stormwater from such a large contributing area. Again, this detention pond is drained by the aforementioned stream, which flows to Holt Pond.

Figure 2-7. View of the Detention Pond from Blackstone Drive Showing the Outlet. This Marks the Beginning of the Unnamed Brook Entering Holt Pond.

The detention pond at Blackstone Drive (refer to Figure 2-6) in drainage area A receives a great deal of stormwater from the surrounding urban environment. In addition to the visible trash floating in the pond (Figure 3-2), there are large deltas formed at the inlets to the pond, indicating that the pond is working, but it may need to be cleaned. Over a twenty year period, over 200 cubic yards of sediment are estimated to enter the pond, enough to fill over 20 dump trucks. As the pond fills in, the detention time is lessened and more sediment is passed through the pond into a brook leading to Holt Pond.

Dredging the pond could be done in the wet with a conventional long-arm excavator. The machinery could reach much of the material from the pond's perimeter and deposit it into waiting trucks, reducing handling costs. The pond is privately owned by Knightsbridge Arms Condominium Association and they would be an appropriate partner for this project. Direct measurements are not available, but visual evidence in the form of sediment deltas and shallow areas containing rooted aquatic plants suggest that 750-1,000 cubic yards of sediment in the pond that may be removed.

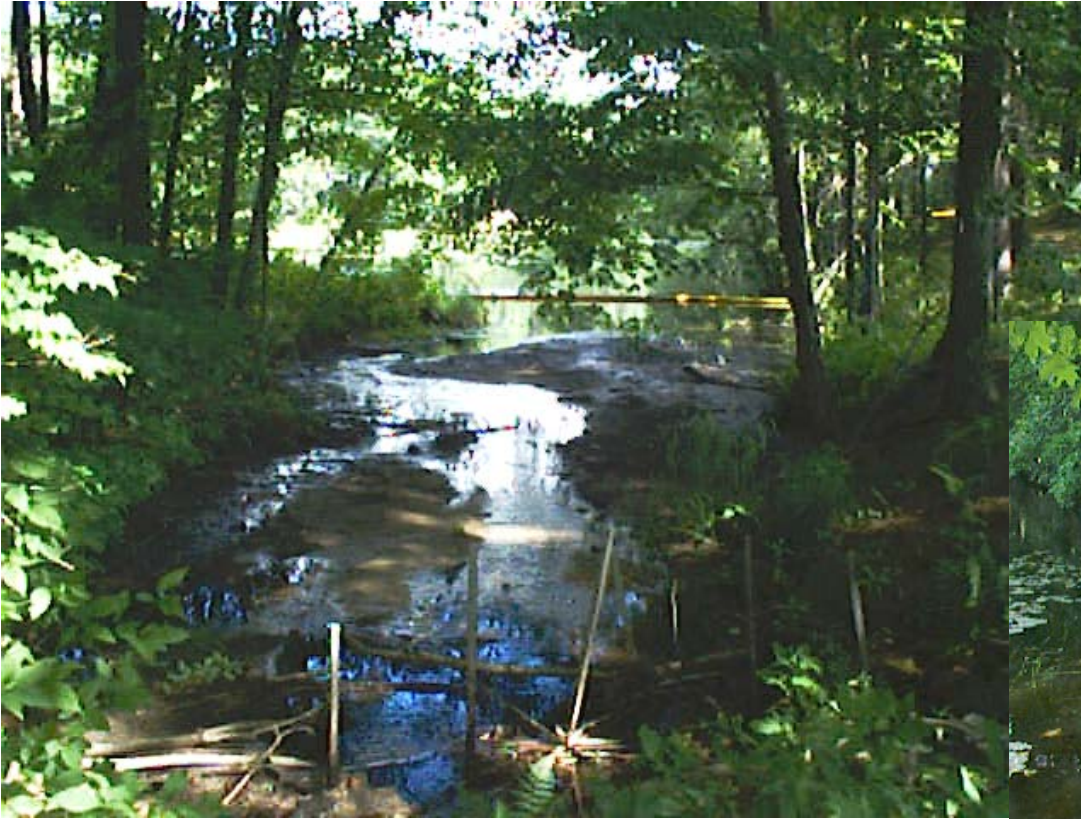
Figure 2-9 shows the stream outlet into Bowers Pond near the Holt Pond Dam. The drainage area that contributes to this stream starts in the Western portion of the Kessler Farm development and continues through the Thorton Village Mobile Home Park and the Water View Homes to Bowers Pond, as mentioned earlier. The outlet of the pond adjacent to Cranleigh News marks the beginning of this stream, from which it travels along the steep gradient to Bowers Pond. There is a sediment delta that has formed where the stream enters the pond. It is likely that development activities and a floating boom (Figure 2-10) have allowed this delta to form. Nonetheless, this stream receives a great deal of water that flows considerably fast during storm events.

Figure 2-9. View Downstream of Tributary to Bowers Pond. Note the Sediment Delta that has Formed.

A floating silt boom, described previously as site B1, likely installed to minimize the impacts from construction activities nearby, is in need of maintenance. Once the construction is complete, and before the City releases any bonds or issues a certificate of occupancy, the developer or his agent should be instructed to remove the accumulated sediment delta.

Pennichuck should request that the developer leave the boom in its location after the cleaning is done. The boom will serve to minimize transport of any additional sediment to the main portion of Bowers Pond. This would require follow-on inspection and maintenance activities.

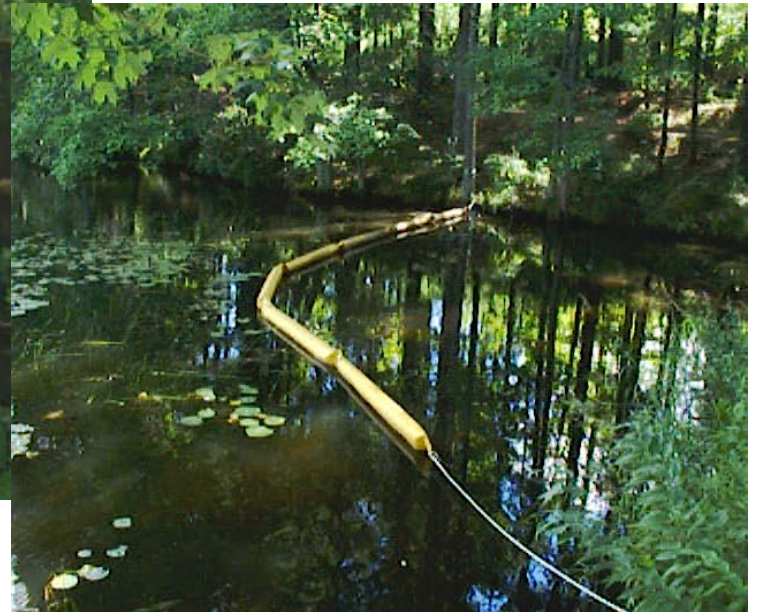
Figure 2-10. Floating Silt Boom that has Created the Sediment Delta.

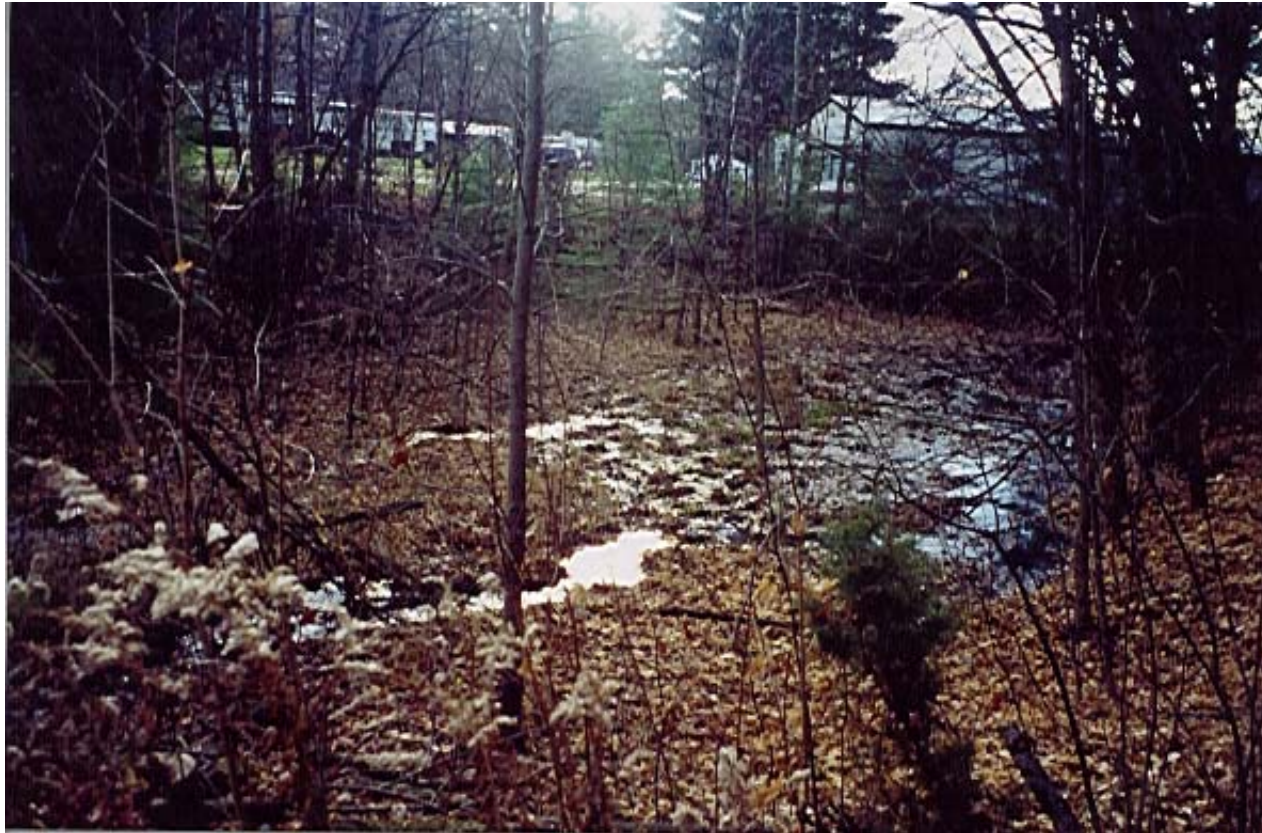
The stream that flows through the Thorton Village Mobile Home Park collects drainage from the Bangor Street area as it is piped under the roadway to a small detention area adjacent to Bangor Street and Larchen Lane. This overgrown detention area (Figure 2-11) is the only location

Figure 2-11. View of Overgrown Detention Area Adjacent to Bangor Street.

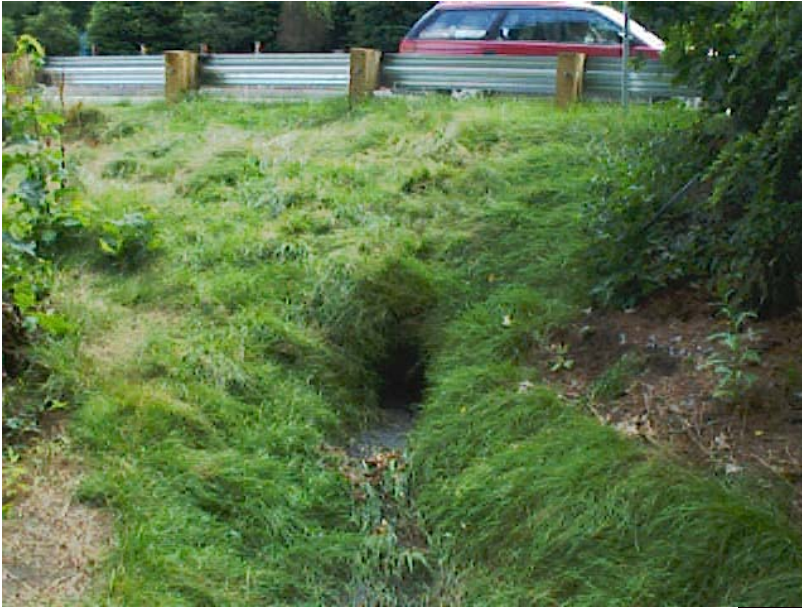
The bridge at Tinker Road is a new structure with a small drainage system that collects runoff from the bridge and the intersection of Thorton and Tinker Roads. Runoff flows from Tinker Road and from both directions of Thorton Road to three catch basins that discharge to a short swale (Figure 2-13) into Bowers Pond. This intersection (Figure 2-14) is located in very close proximity to Bowers Pond and is the site of moderate to heavy traffic given its size.

Figure 2-13. View of Tinker Road Discharge Which Enters Bowers Pond.

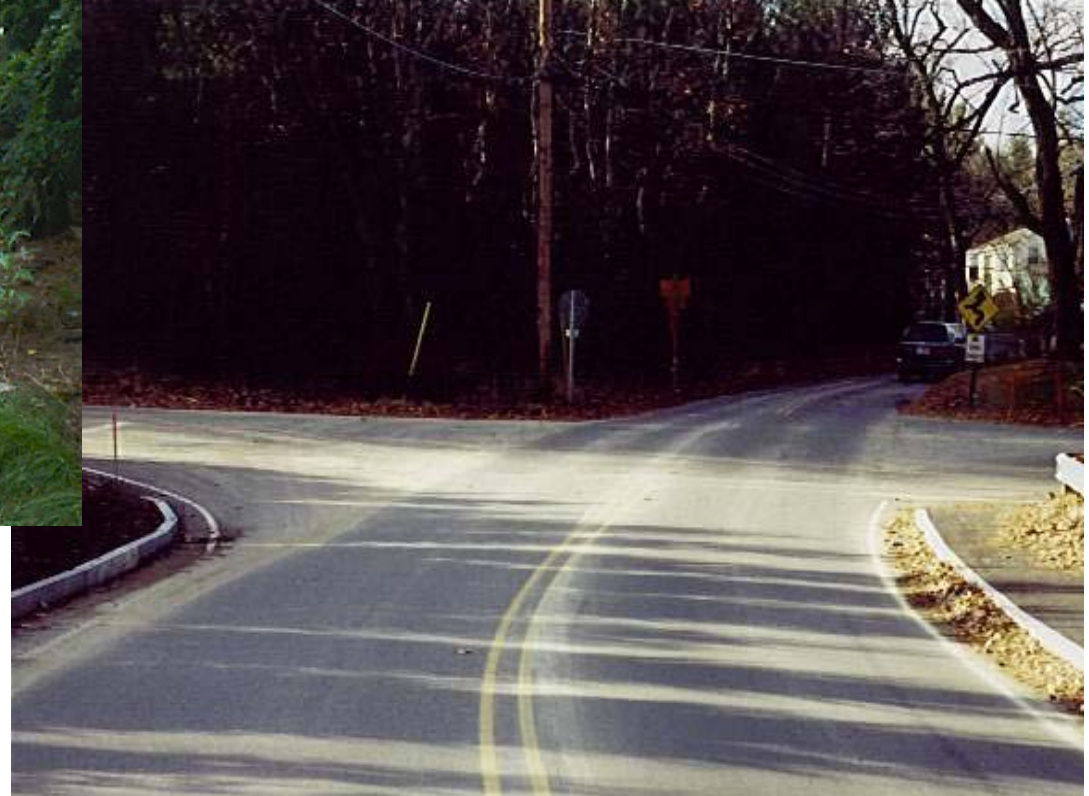
Figure 2-14. View of Thornton and Tinker Roads Intersection. Potential Spills from Vehicle Accidents at this Intersection have a Direct Route to Bowers Pond.

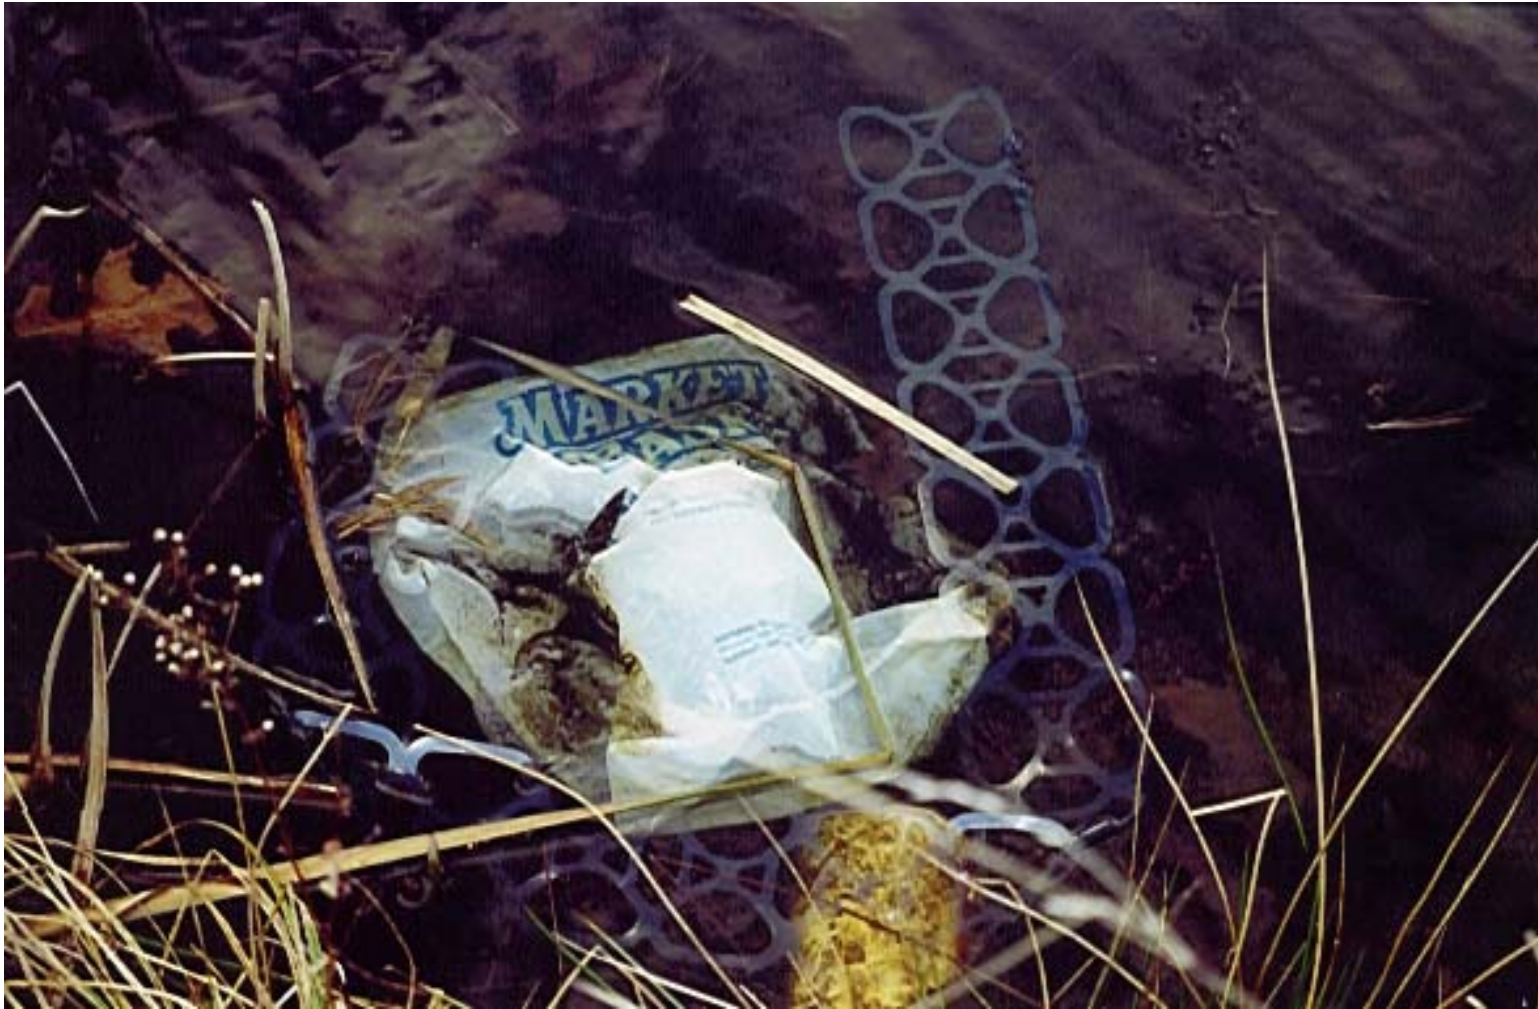
Figure 3-2. Typical Trash Found Throughout Blackstone Drive Detention Pond.

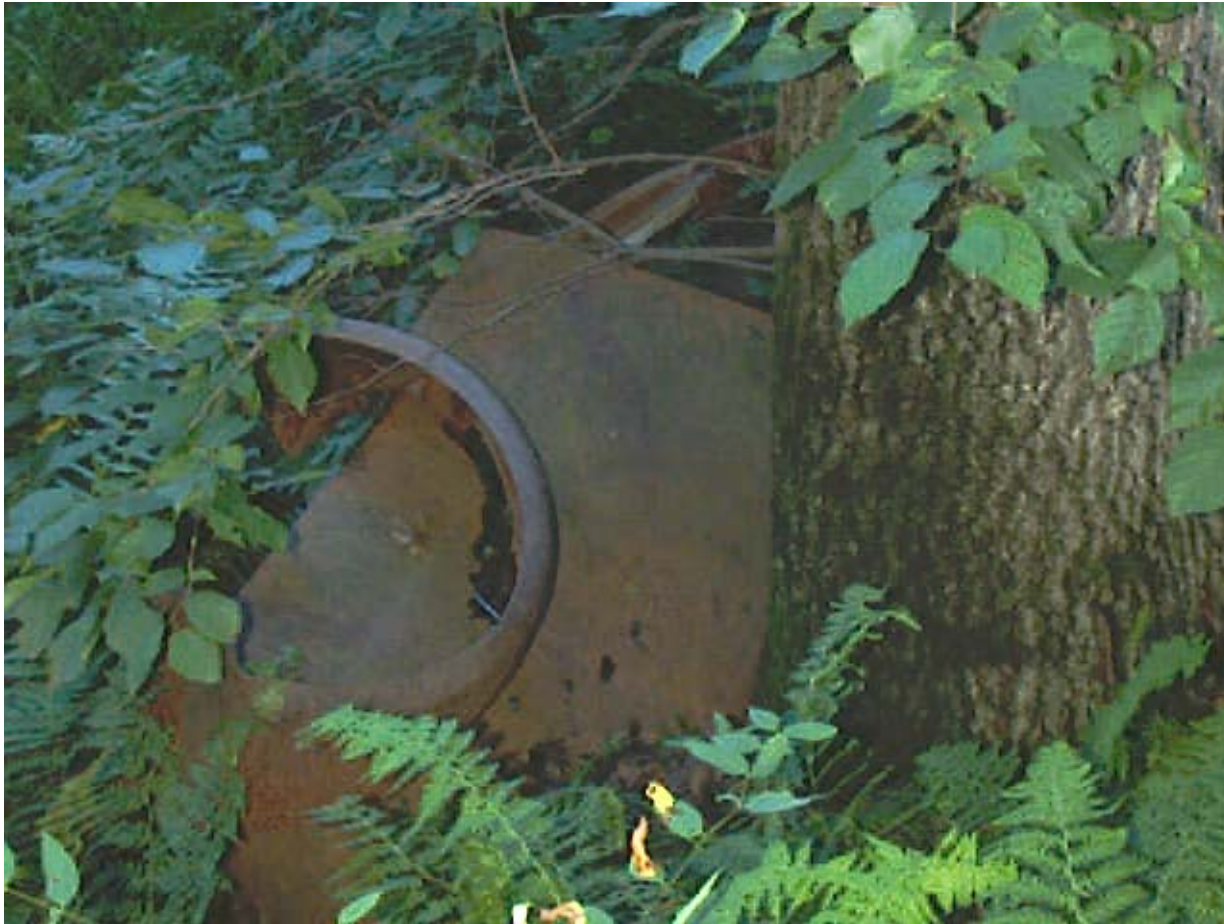
During field investigation of drainage area A, an old dumping site was noticed. The site is located at the end of Millwright Drive in the bank adjacent to Holt Pond (Figure 3-3). The waste extends nearly into the pond and consists mainly of rusted metal car parts and other unidentifiable metal objects. No drums were observed. The site appears to be fairly old and probably originated during the development of the site. There is no obvious threat to water quality, but an investigation into

Figure 3-3. Metal Parts and Debris at an Old Dump Site Located Along Holt Pond Near the End of Millwright Drive.

the history of the site and its composition should be done to eliminate this uncertainty.

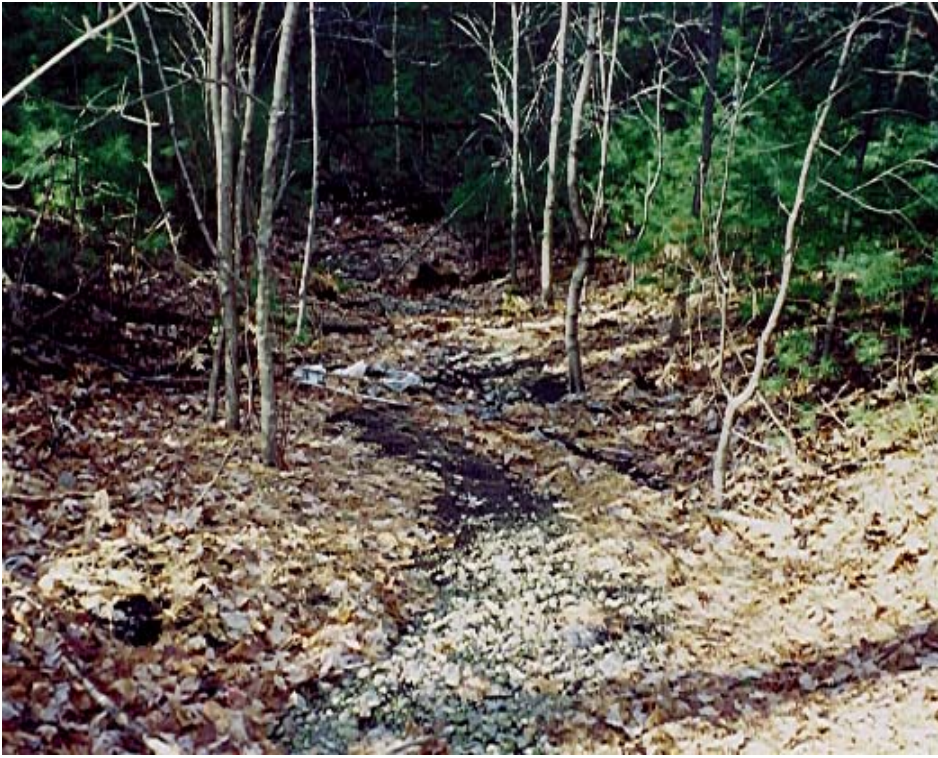
The detention pond located Northwest of Watersedge Drive between Fencroft and Oriole Drives receives drainage from a portion of Thorton Road and the Watersedge Drive development. There is significant stormwater flow to the pond indicated by the scoured swale inlets of the pond (Figure 3-4 and 3-5). The detention pond serves more as a retention pond and appears to adequately store and treat stormwater. During large storm events the pond overflows and discharges into Holt Pond through an overgrown swale outlet. The stormwater treatment capacity of the pond could possibly be increased by the introduction of wetland plants along the relatively barren edges of the pond.

Figure 3-4. View of the Scoured Swale that Enters the Detention Pond from One Watersedge Drive Discharge.

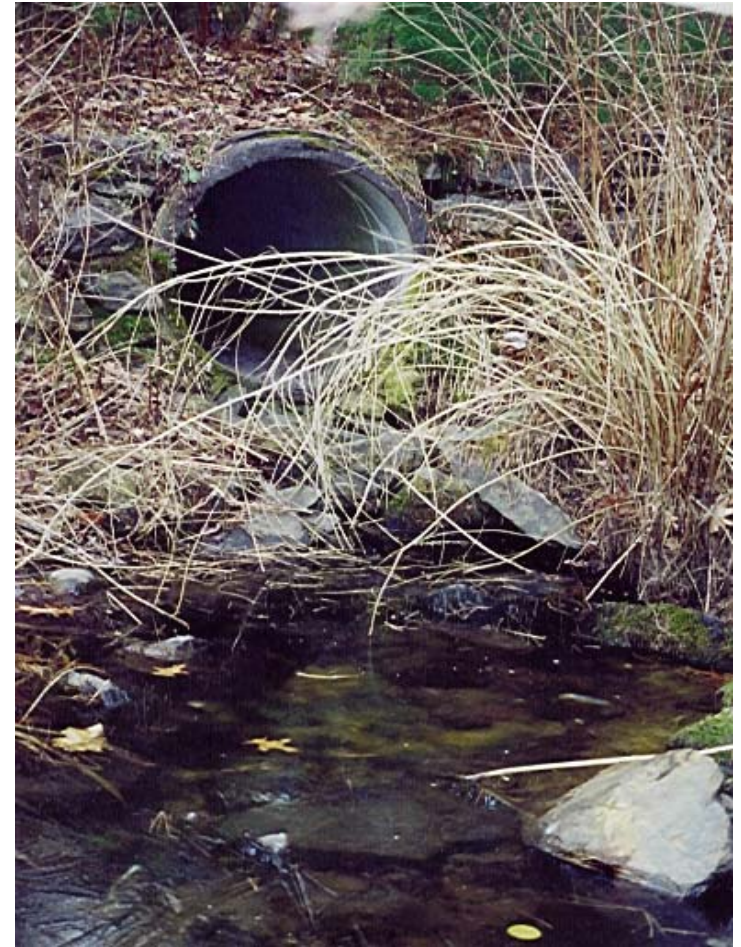
Figure 3-5. View of Second Watersedge Drive Discharge into Detention Pond. The Swale Area Immediately Below is Scoured.

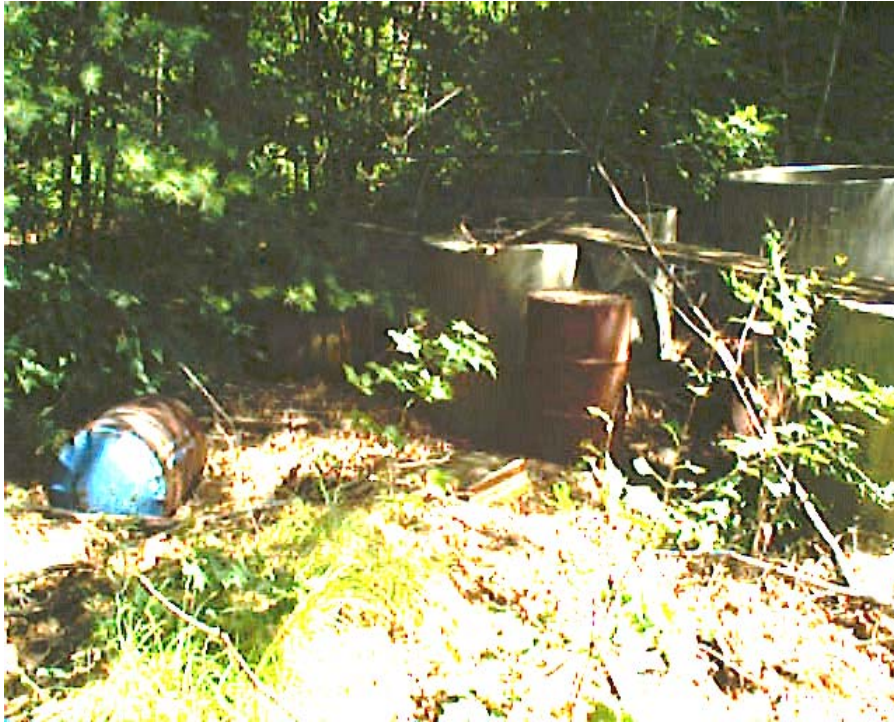
An abandoned construction material storage site was identified in the Thorton Village Mobile Home Park, adjacent to Greatstone Drive (Figure 3-6). Several old steel drums that contained petroleum products were noted in addition to various pipes, drainage basins and related structures, and granite curbing (Figure 3-7). All of the drums were apparently empty and undamaged. In addition to these drums a “drum bridge” was observed in the stream (Figure 3-8). The historical use of the site should be investigated to determine if there were any releases of hazardous materials, to eliminate any uncertainty of a threat posed by the site.

Figure 3-7. Old Construction Materials Storage Area in Thorton Village Mobile Home Park.

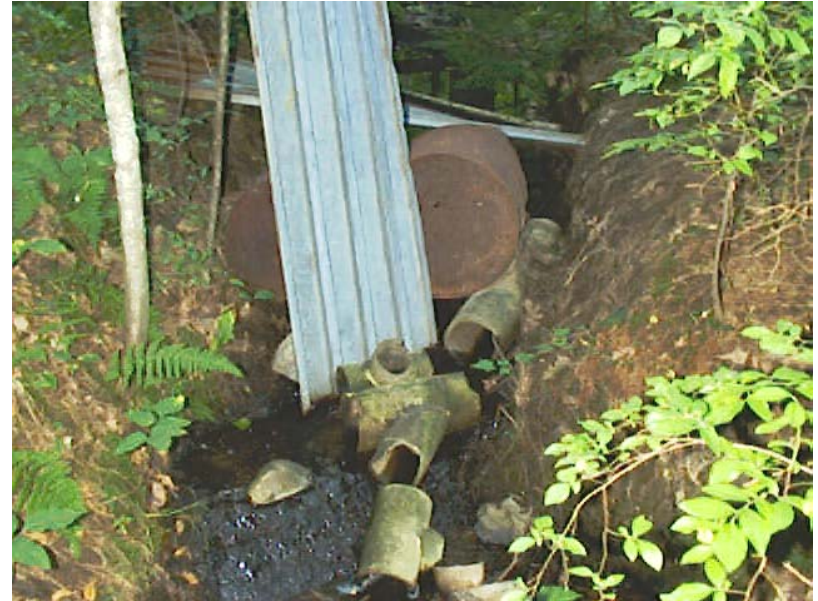
Figure 3-8. “Drum Bridge” Located in Stream Next to the Old Construction Materials Storage Area. This Stream is a Tributary to Bowers Pond.

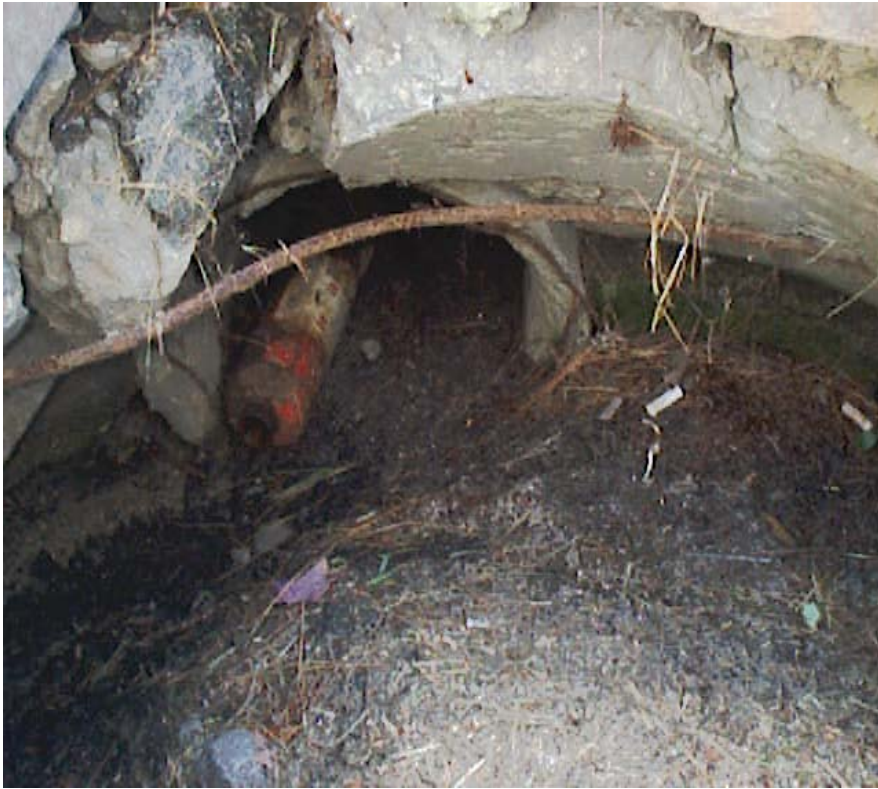
The closed drainage system in Thorton Village flows to Thorton Road and then North past Greatstone Drive, where it exits into a retention area adjacent to the end of Larchen Lane. This drainage system is in need of maintenance. The majority of catch basin sumps were completely filled with sediment, some of which extended past the pipe invert (Figure 3-9, note the propane cylinder). The retention area serves as an adequate sump for stormwater, but the discharge from the collection system into the retention area is clogged (Figure 3-10). There is also a catch basin upgradient of the inlet that is missing a cover. This should be replaced by the owner.

Figure 3-9. Thorton Road Catch Basin Full of Sediment and in Need of Maintenance.

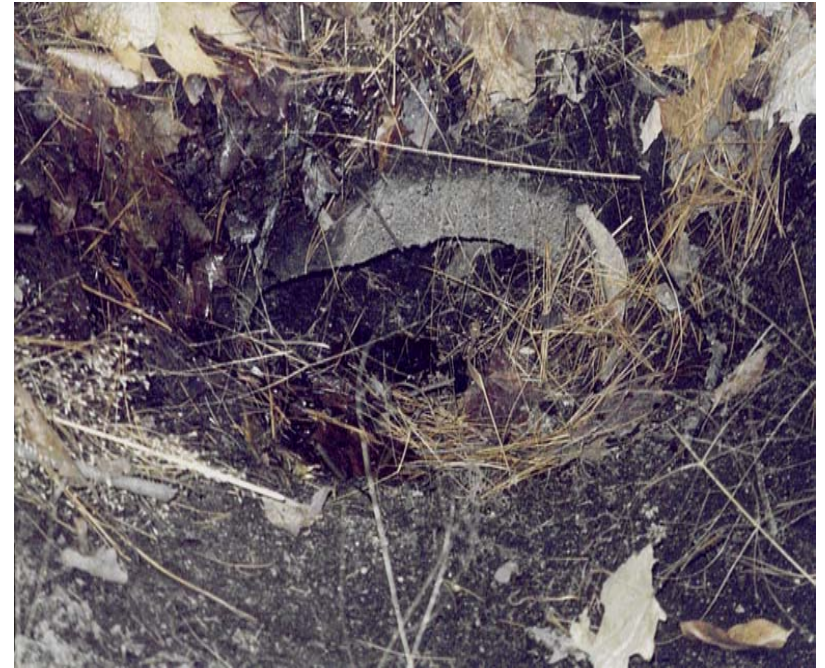
Figure 3-10. Clogged Discharge Near Larchen Lane. Sediment has Built Up Around the Pipe such that It is Actually Below Grade.

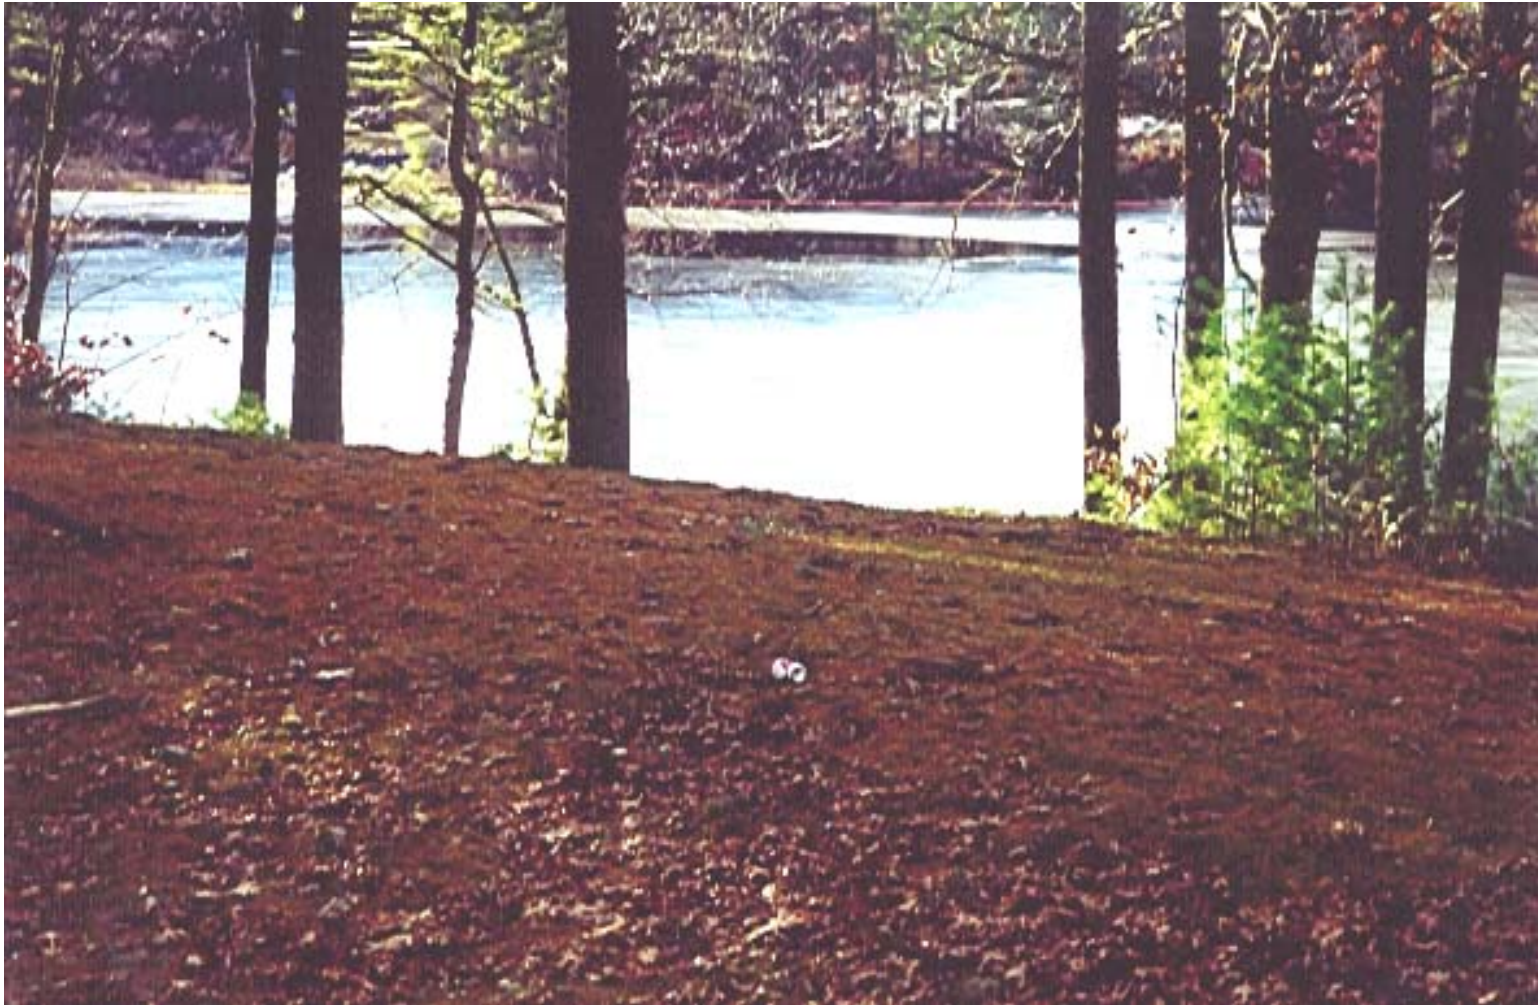
indicated that the tank was scheduled for removal and later field inspection confirmed the tank removal (Figure 3-11). It should be confirmed that the tank was removed using standard practices and the underlying soils were free of contamination.

Figure 3-11. Former Site of Underground Storage Tank in the Bank of Bowers Pond. The Bank and Surrounding Area has been Restored to its Original Condition.

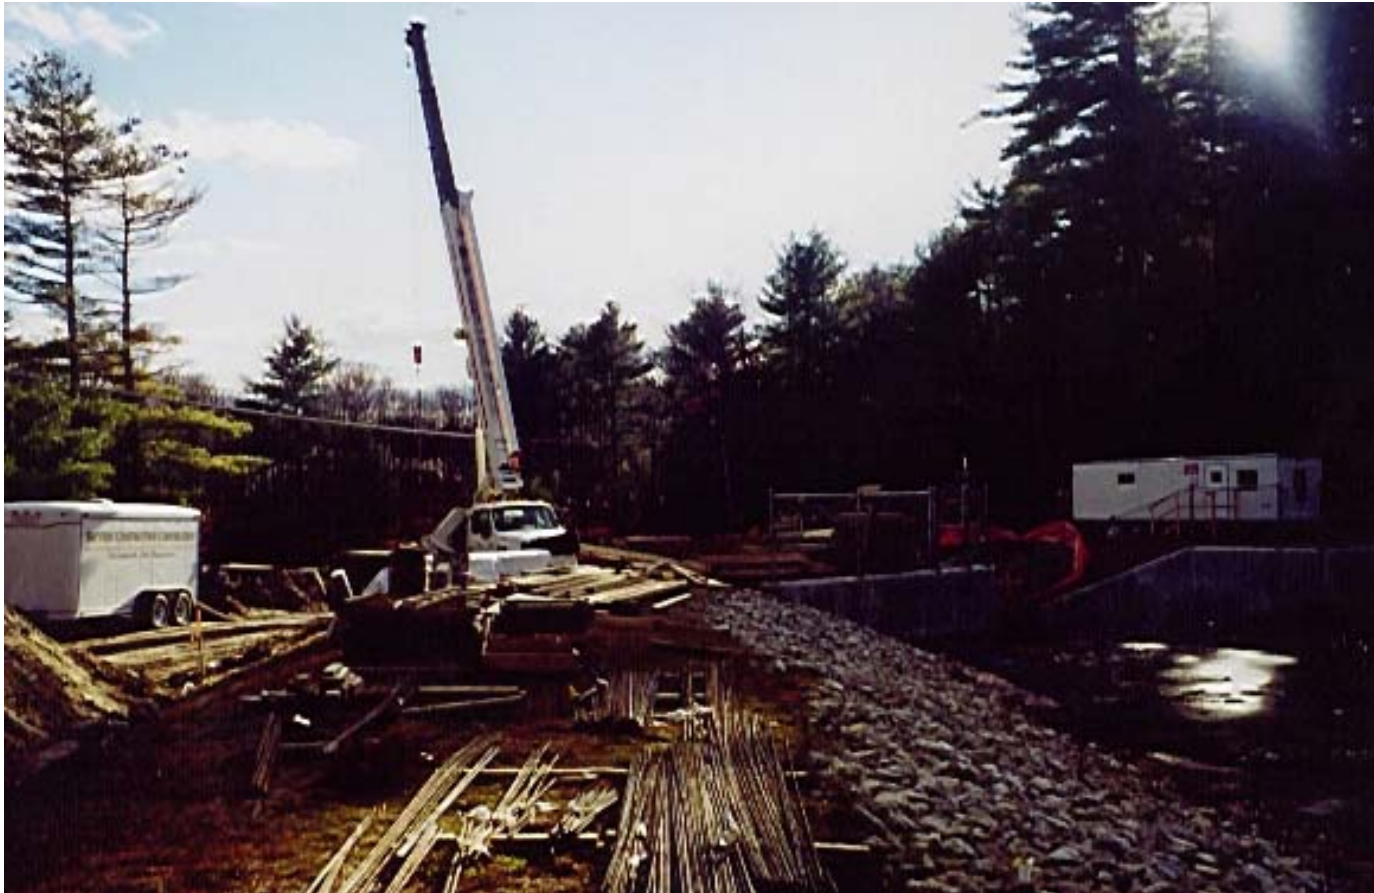
The bridge at Thorton Road is currently being reconstructed to handle two-way traffic Figure (3-12). Similar to the bridge at Tinker Road, the bridge is downgradient of Stuart Drive and both directions of Thorton Road. Drainage from the roads flows to the bridge and off of the edges of the roadway into Bowers Pond. Some of the drainage from the intersection of Stuart Drive and Thorton Road flows onto a grass strip West of Thorton Road. The edges of the roadway around the bridge currently have a narrow vegetative buffer to the pond. This minimizes the impact of stormwater to some extent by allowing for some natural attenuation. The final drainage plan for the new bridge includes two swales located on either side of the bridge (shown as Appendix A). It is recommended that the swales be inspected to ensure adequate vegetation establishment.

Figure 3-12. Construction of a New Bridge on Thorton Road. The New Construction Incorporates a Swale System that Handles the Runoff From Thorton Road.

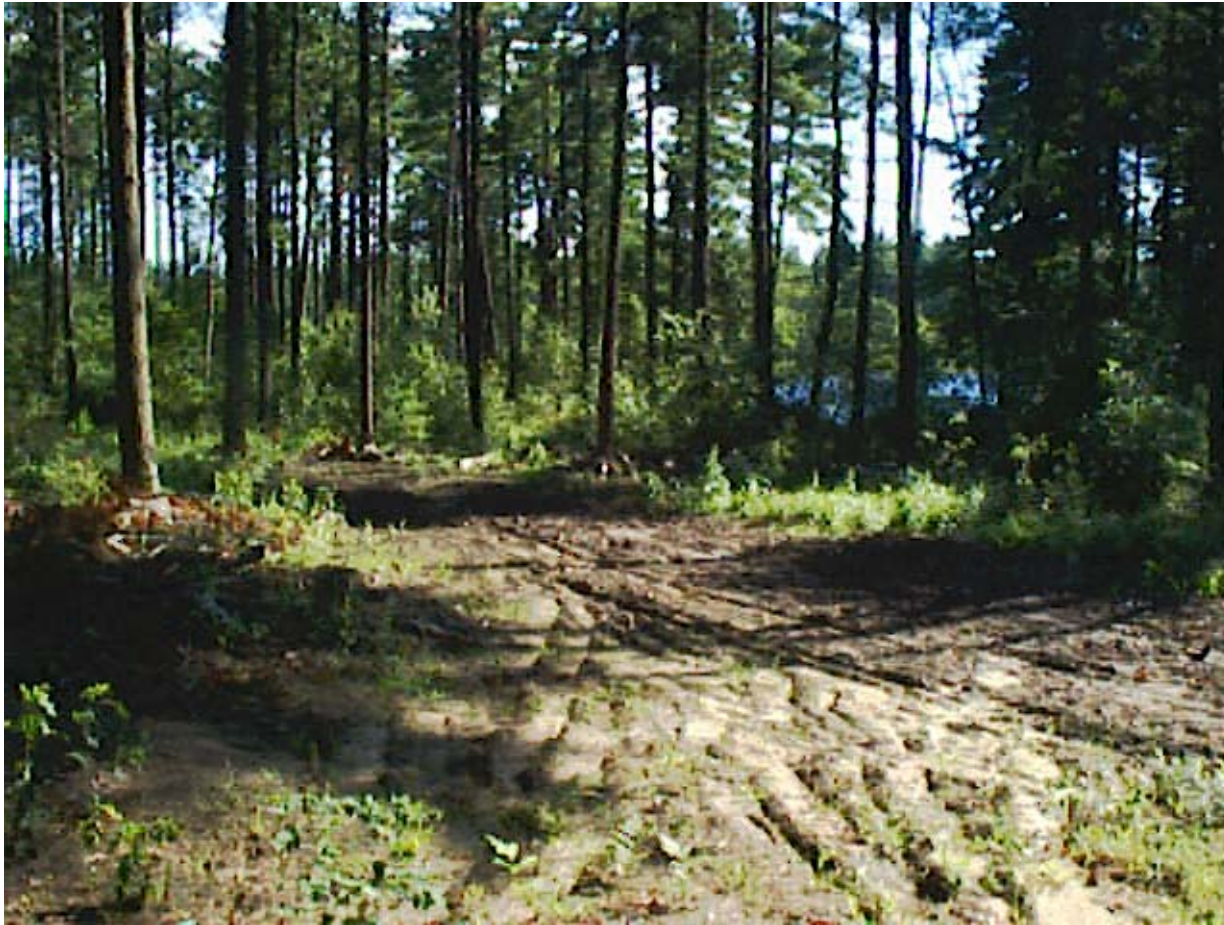
Logging activities were noticed on land immediately adjacent to the Northern borders of both Bowers and Holt Ponds (Figure 3-13). Such activities in critical buffer zones can have significant impacts on water quality. At the time of the site visit it did not appear that the either Holt or Bowers Ponds were being impacted from the recent logging activity. The Town of Merrimack should be contacted and asked to allow Pennichuck to review proposed logging operations that will take place within 200 feet of the ponds or its tributaries. This review should take place prior to an approval of the Intent to Cut Permit.

Figure 3-13. Logging Activities on Lands Immediately Adjacent to Bowers and Holt Ponds (Merrimack).
